**Innovative Masking of Ferrous Inserts in Magnesium
Aerospace Components Prior to Tagnite Anodization
(v.1, Unlimited Release)**

ARL-CR-716

July 2013

**Technology Applications Group, Inc.
810 S. 48th St.
Grand Forks, ND 58201**

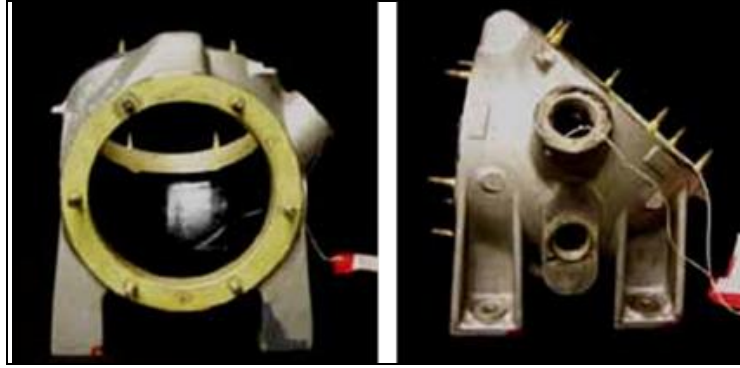
Figure 13. The as-received condition of the H-60 center housing.

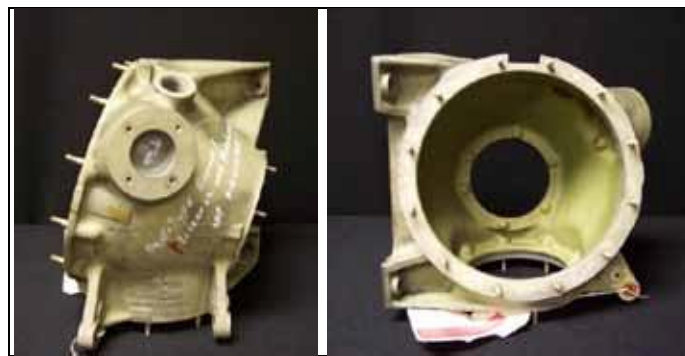
Figure 14. H-60 gearbox housing shown in as-received condition.

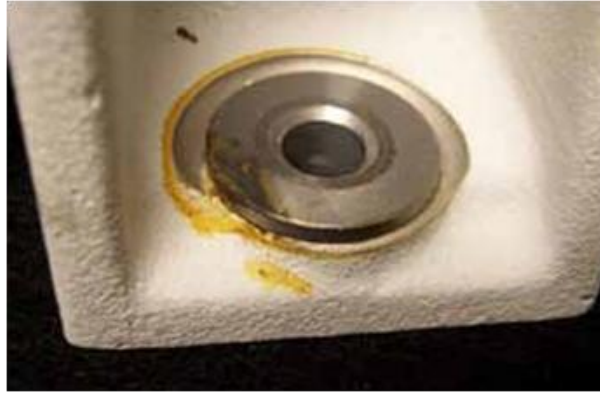
The mounting pad bushings were initially masked using top and bottom covers with O-rings, where the bottom cover threaded into the top cover to provide the necessary seal. Initial attempts at masking these bushings were met with high failure rates due to leakage around the top part of the bushing, as seen in figure 19. The machine face buttons were masked using 6061 aluminum covers with O-rings that were held in place with a bridge attached to the aluminum stud covers (figure 20). The initial masking attempt suffered from minor leakage due to alignment problems with the covers, as seen in figure 20, lower right. The bottom of the studs that penetrated the as-cast surface (figure 17, lower right) were first masked using a matching cover with an O-ring connected by a linkage to the other masking tools, as seen in figure 21. This methodology worked well, but installation was very complicated.

Figure 19. Example of masking tool failure around mounting pad.

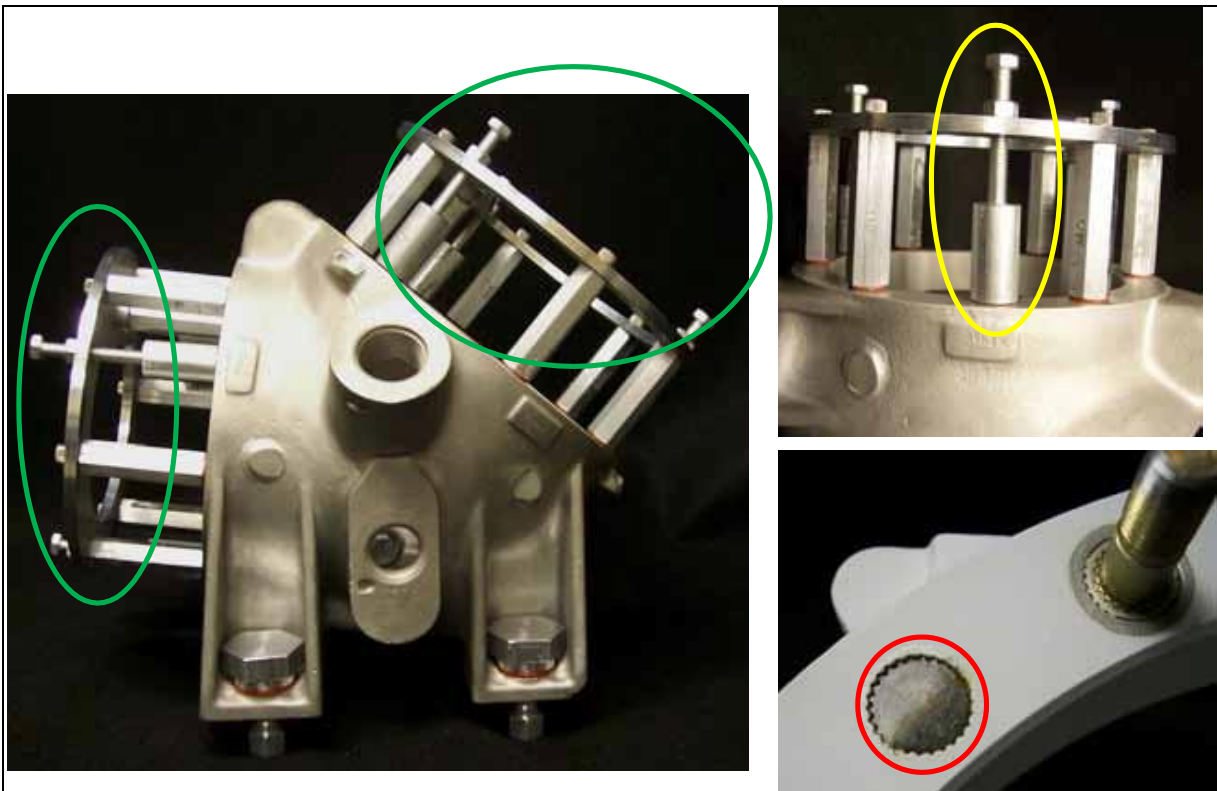
Figure 20. Masking of machine face buttons on H-60. Left: bridges (green) that support machine face button covers. Upper right: machine face button cover (yellow). Lower right: damage to button after Tagnite (red).

1. UV curable maskant was applied to the buttons on the machine faces instead of using the bridge with the insert covers. Also, the bottom studs were masked using the UV maskant because the initial linkage masking arrangement was cumbersome and the installation time consuming (figure 22).

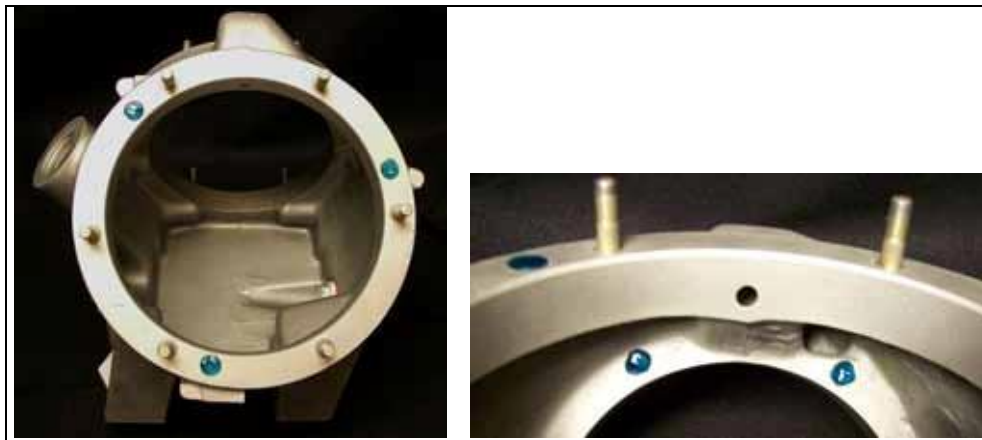
Figure 22. UV curable maskant on H-60 component. Left: UV maskant covering buttons on machine face. Right: UV maskant covering stud buttons on inside lip of component.

- The UV maskant held up well, but to get the best results, the UV maskant must completely cover the buttons or stud bottoms along with some overlap (1/32 to 1/16 in) onto the magnesium portion of the casting.
- The shoulder on the mounting pad bushing cover could force the O-ring below the lip of the bushing, which would cause a gap between the O-ring and the cover. This movement would result in Tagnite electrolyte reaching the surface of the bushing and oxidizing the surface. We must exercise care when installing the cover to avoid pushing the front part of O-ring out of position.

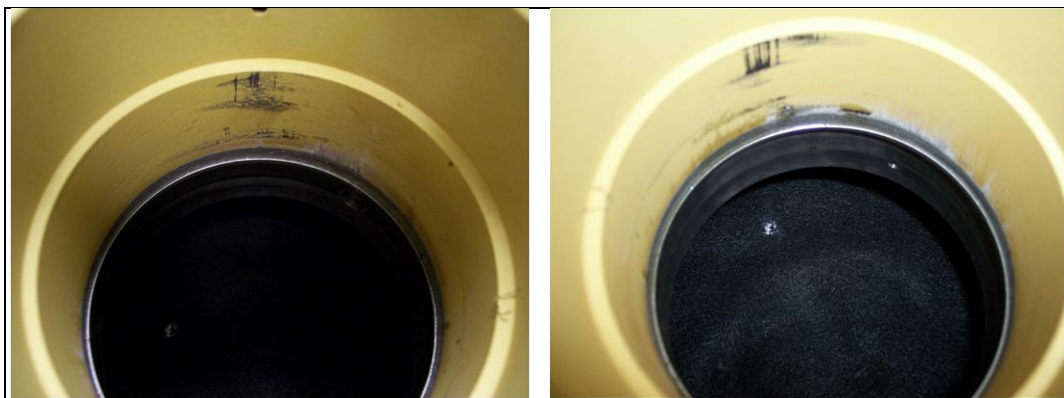
Figure 44. Damage to interior of H-64 tail rotor cover during masking removal.

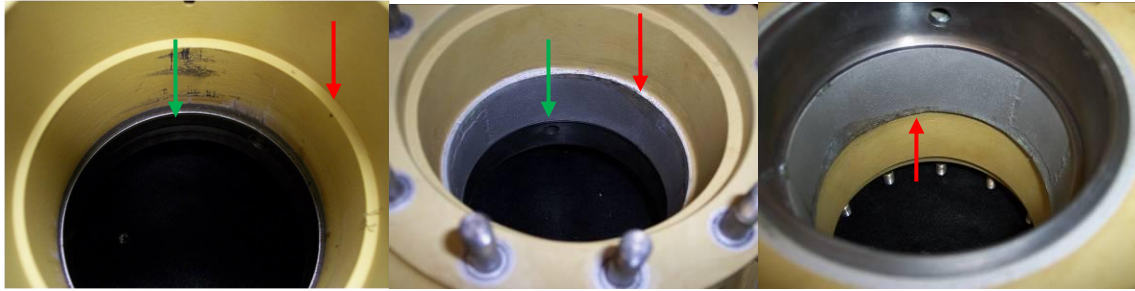
The masking was then installed on a second H-64 tail rotor cover. During the installation of the covers for the steel liner, it was discovered that the steel liner on the second tail rotor cover was installed flush with the interior wall of the cover. Therefore, the lip that the top cover could rest on was no longer present. So the top cover was modified to fit on a second lip that was higher up the interior diameter. The drawback to this approach was that a large area of uncoated magnesium would be present after the masking was removed above the steel liner (figure 45). This would have to be touched up with Brush Tagnite.

Figure 45. H-64 tail rotor cover – steel liner masking. Left: original cover had a raised steel lip that the cover could rest on (green arrow). Second cover did not have the raised lip and cover was installed on lip in the as-cast section of the interior diameter (red arrow). Center and right: second cover after Tagnite showing the large uncovered area after the masking removal.

On the second cover, there was no failure of the masking, but there was a larger area of uncoated magnesium that needed brush Tagnite touch-up.

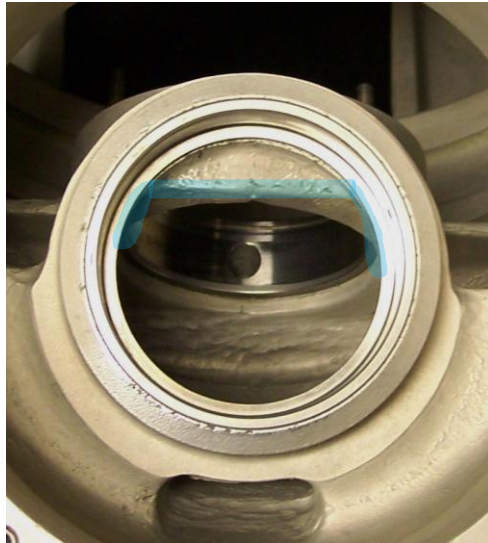
The upper or top steel liner (figure 53) is difficult to seal because of the three-quarters moon-shaped bottom of the liner. All of the leakage occurred next to this small shelf on the bottom of the liner. After multiple attempts at sealing this liner, the best approach was to provide multiple layers of protection.

Figure 53. Top steel liner of H-64 intermediate gearbox. Blue shaded area represents primary leakage areas.

develop masking material that can be compressed against the back plate to seal off the bottom of the liner. This was accomplished by using mold material sized to the shape of the liner walls. The mold material is compressed with a plate to force the mold material into the voids of the support plate and the steel liner/magnesium as-cast interface. Lastly, a cover is needed for the top part of the liner.

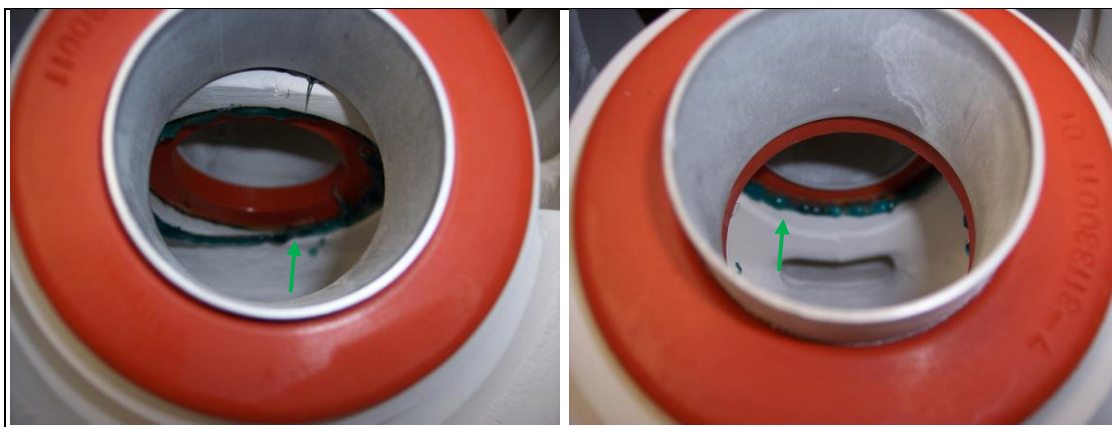
During the installation process, TAG personnel discovered that the masking inserts did not protect the bottom of the liners (figure 56). The solution was to attempt to seal the bottom areas of the steel liners with the Dymax UV curable maskant. Inspection of the UV maskant after the Immersion Tagnite process showed that the UV maskant held up well.

Figure 56. View of UV maskant around the bottom of the steel liners after Tagnite.

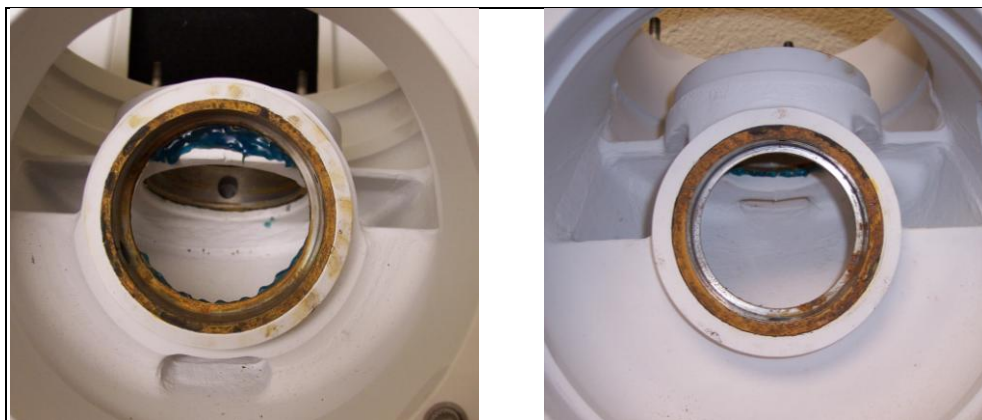
Once the steel liner covers were removed after Tagnite, it was immediately evident that the Acme masking tools were not robust enough to survive the Tagnite process. The steel liners had lots of damage caused by a total lack of sealing around the steel (figure 57). After the rust was removed, there was evidence of pitting on the steel, which indicated that the leakage was present during the Tagnite anodize portion of the process; this leakage left the steel liner unusable. The Acme masking was quickly abandoned because of the extensive leaking during the Tagnite process.

Figure 57. Extensive damage to the steel liners after removal of Acme masking tools. Left: top steel liner. Right: bottom steel liner.

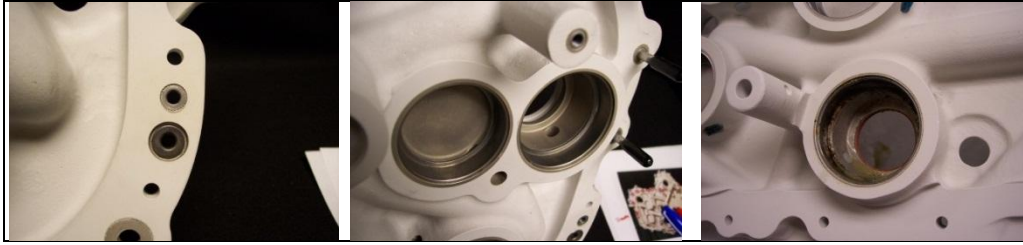
The masked H-47 accessory cover was run through the Immersion Tagnite bath using the same conditions that a new aerospace magnesium casting without any mixed metal would be processed in the TAG production line. After the Immersion Tagnite process, the masking was removed, and the part was inspected (figure 65). There was only one problem seen after the removal of the masking: one of the recessed bearing races had some rust. The rust was easily removed, and the source of the leak was traced to a silicone plug that had fallen out. There was no pitting on the bearing race, which implies that the rust formation occurred after the Tagnite process (figure 66).

Figure 66. Various mixed metal inserts on H-47 accessory cover after Immersion Tagnite process. Left: perimeter inserts. Center: recessed and through bearing races (no damage). Right: through bearing races with light rust damage.

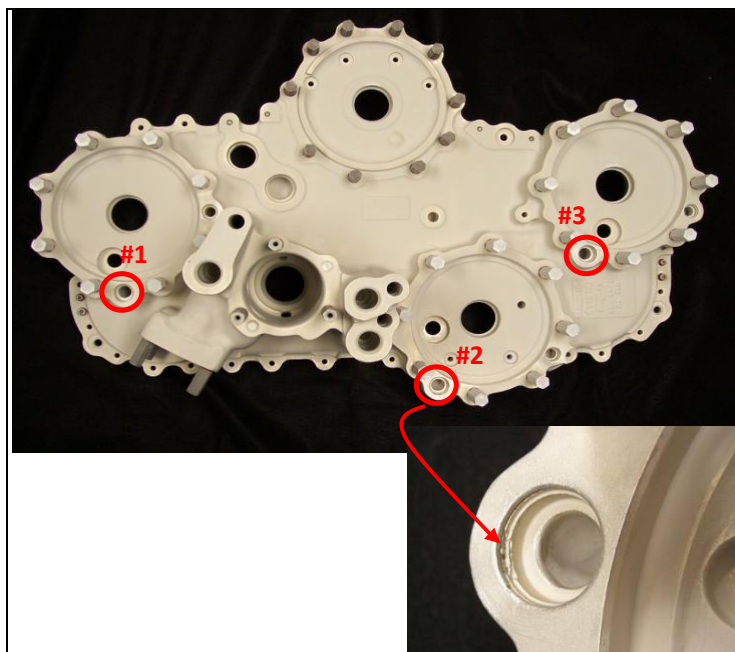
Figure 70. Location of snap ring grooves with corrosion damage. Insert shows location with greatest corrosion damage in snap ring groove.

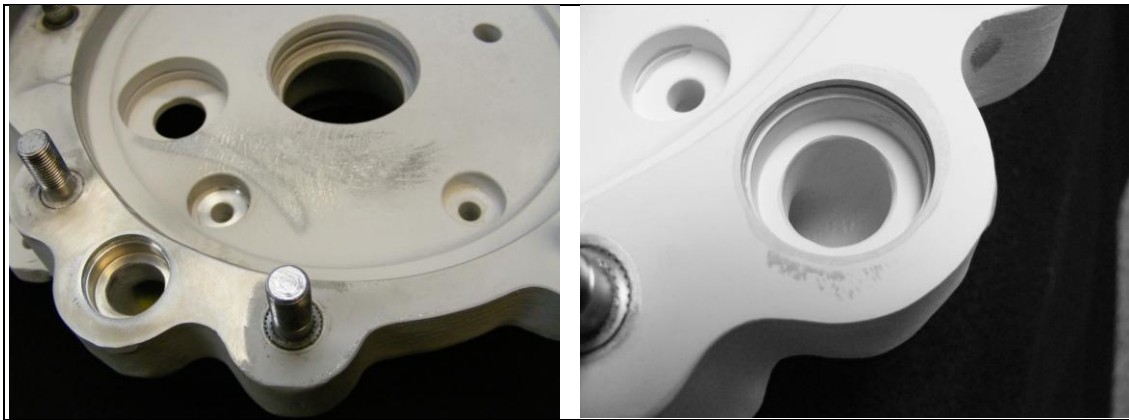
Figure 71. H-47 accessory cover – snap ring groove cold spray repair. Left: after cold spray and remachining. Right: after Immersion Tagnite.

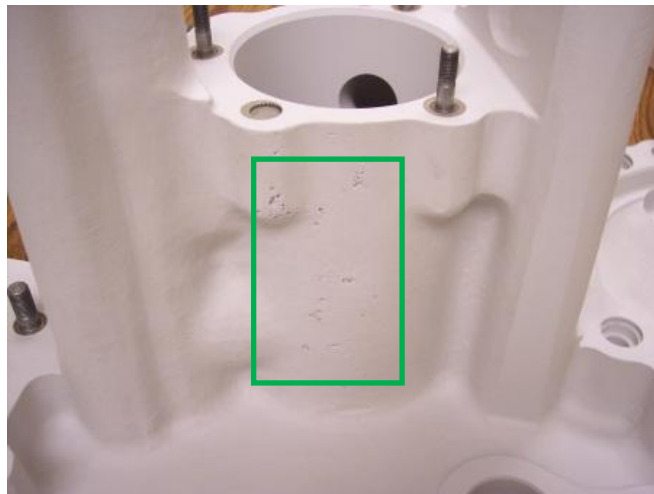
Figure 72. Location of porosity on as-cast surface to be cold spray repaired.

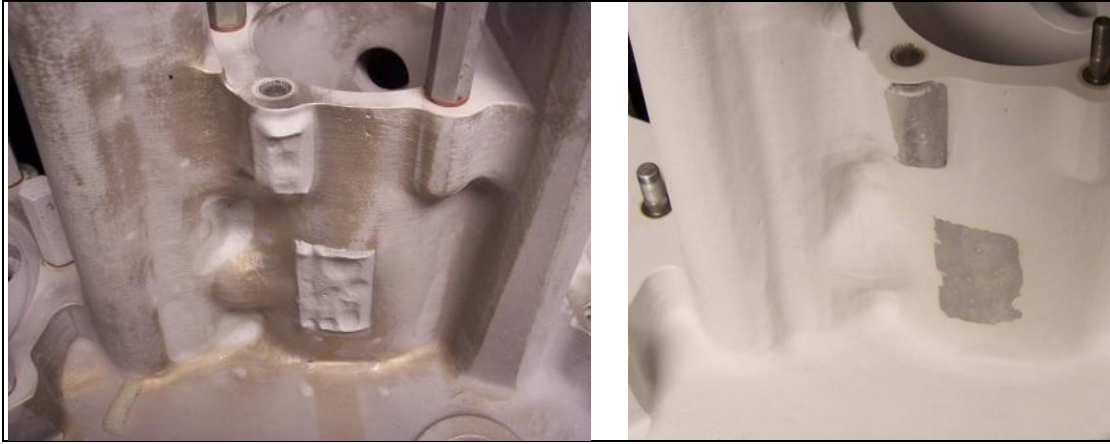
Figure 73. Cold spray repair of as-cast surface on H-47 accessory cover. Left: after cold spray repair. Right: after blending of repair and Immersion Tagnite.
